Thornton Tomasetti

November 12, 2020

RE: RECOMMENDATION FOR COURSE OF ACTION AT ARECIBO OBSERVATORY
TT Project No. U20209

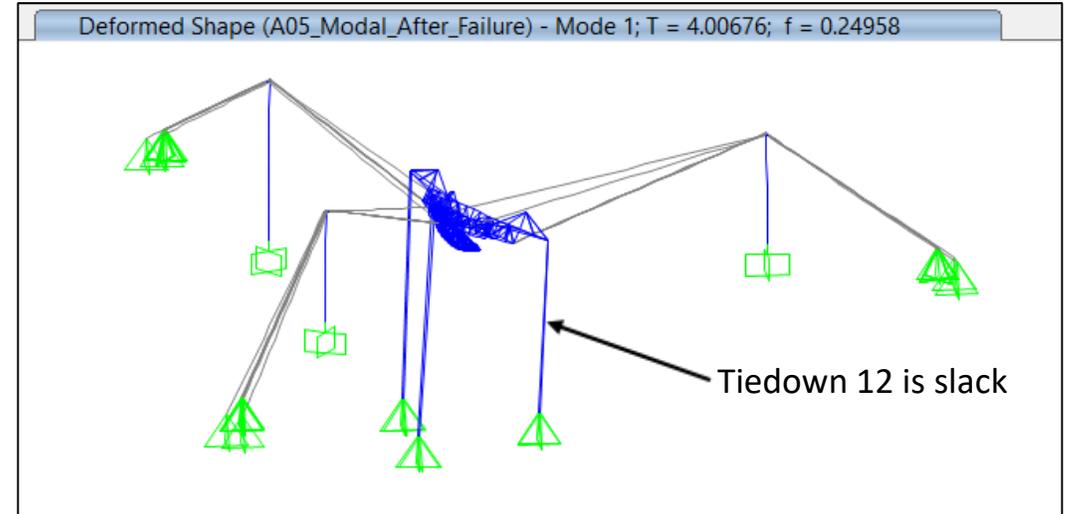
Modal analysis with total structure mass of 1,826 kip and tiedown 12 removed

→ **f = 0.233 Hz**
→ **T = 4.30 s**

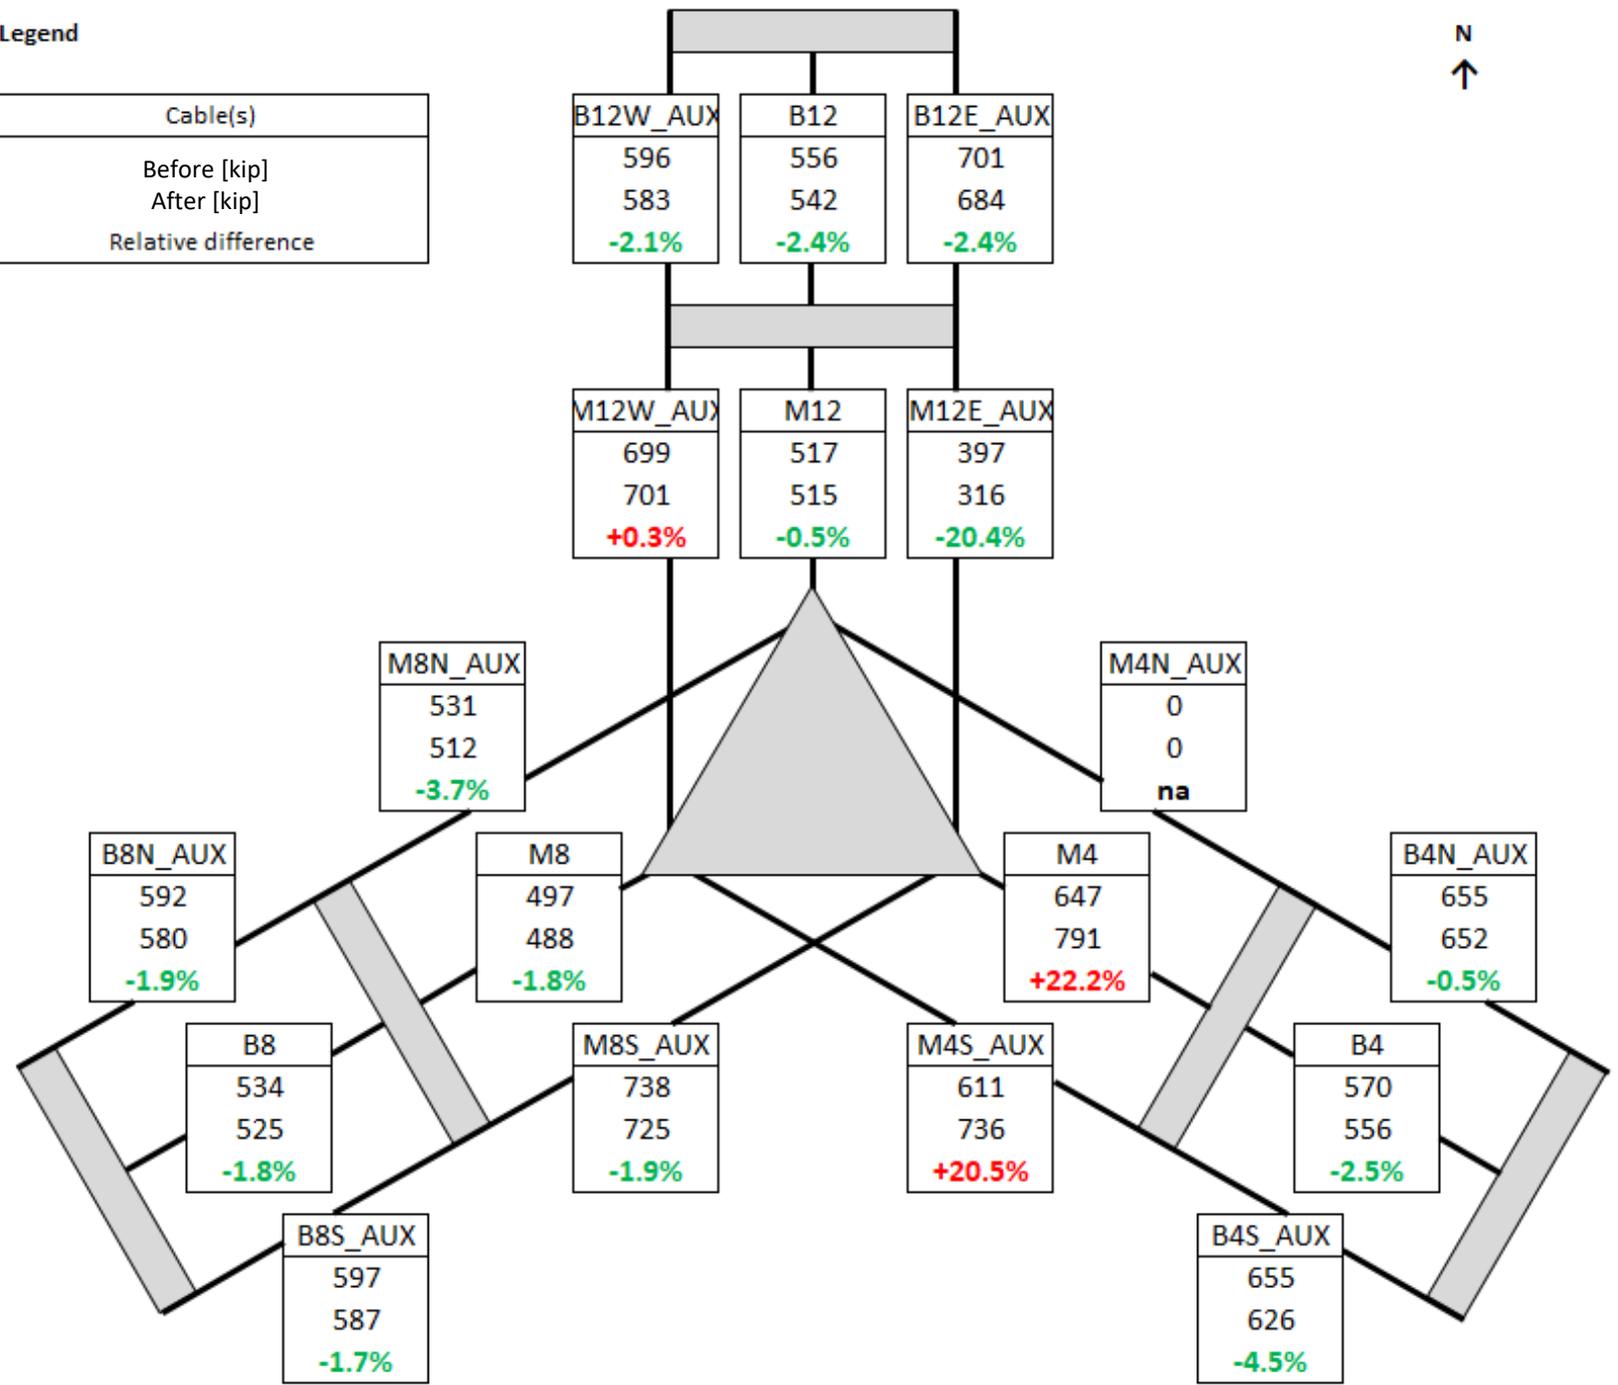
Cable Force Change Due to Second Cable Failure

Another cable failed on November 6. This cable was one of the four 3-inch-diameter original cables also supporting the platform from Tower 4. These original cables had been operating at a factor of safety of 1.67, based upon specified minimum breaking strength for the cable just prior to failure. This corresponded to a load or tension force of 647 kips (1 kip = one thousand pounds) in the original cables. The tension in the remaining three original cables has increased from the 647 kips to 790 kips. This places them at a factor of safety of 1.32 (force in cable/specified minimum breaking strength = $790/1044$). This is nearly 75% of the specified

minimum breaking strength. The original cable failed near the anchor socket at the tower but did not pull from the socket. The design of the original structure and the upgrade in the 1990s intended a factor of safety of 2.1 or more for the cables.

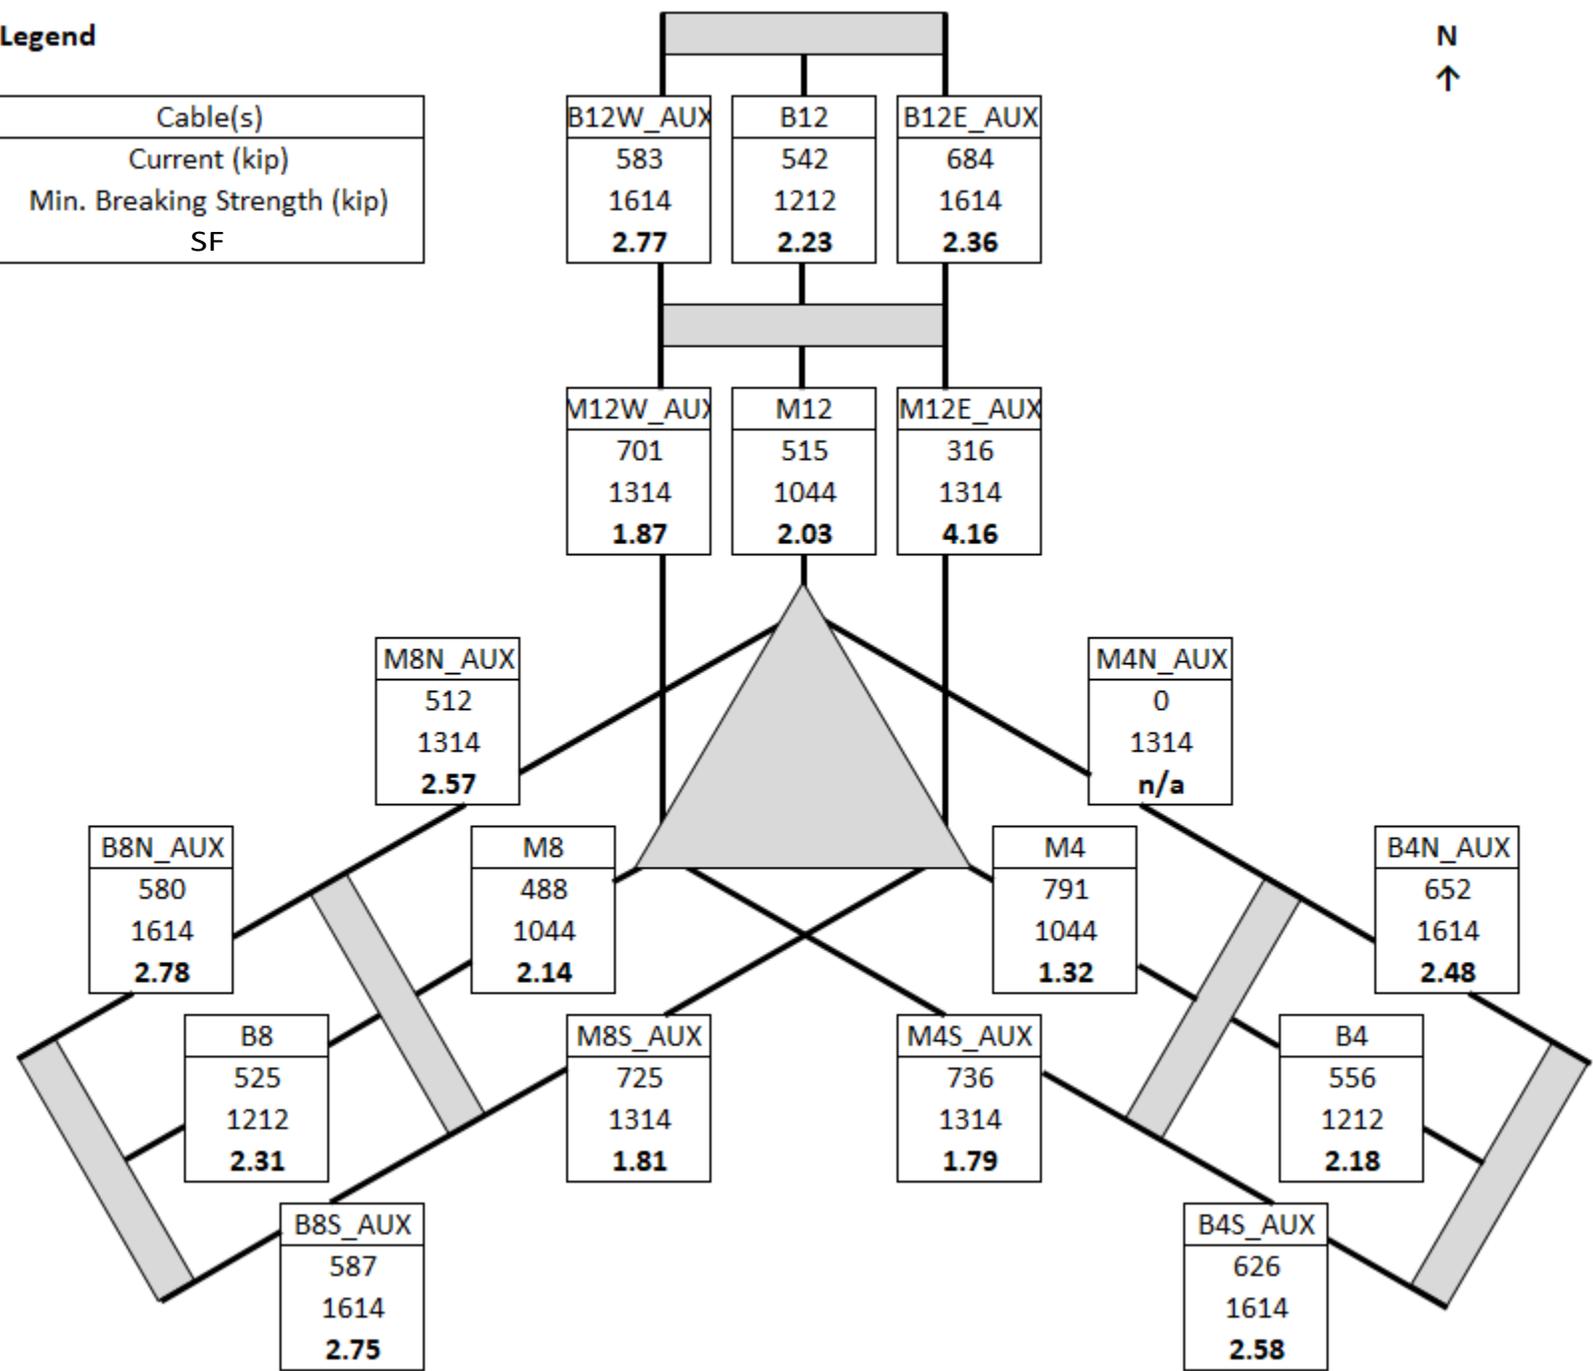
Cable Safety Factors Current Condition

With the loss of two cables, there are now three original cables (of four) and one auxiliary cable (of two) connecting the platform to Tower 4. Should another of these three original cables fail, the two remaining original cables will undergo static force demands at or above the specified minimum breaking strength. A catastrophic failure would be very likely. These cables are not capable of handling the required dynamic demands of a sudden failure of an adjacent cable. The structural redundancy is no longer available and cannot be factored into determining safety.
